Warwick Railway Station Conservation Management Plan

Conservation Management Plan

Warwick Railway Station

Lyons Street, Warwick, QLD

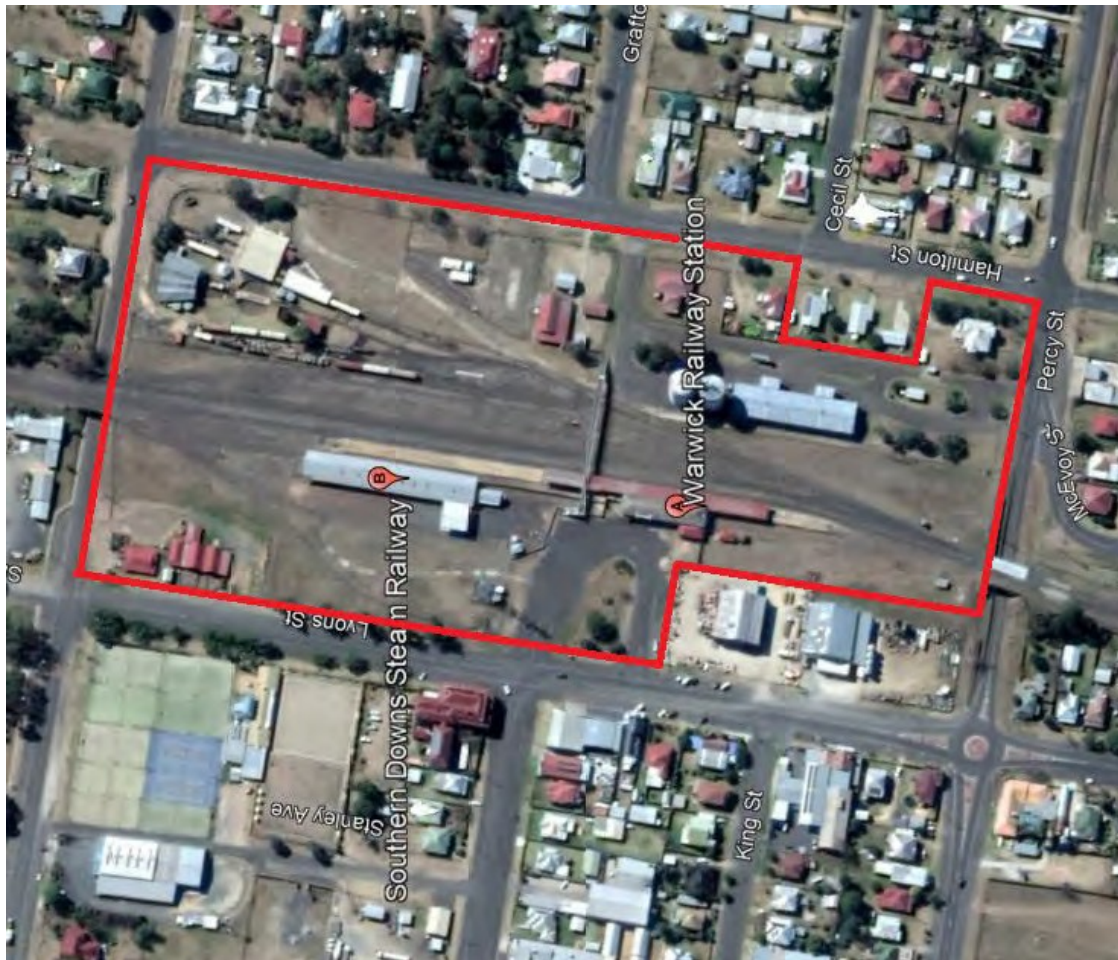
Figure 2. Warwick Railway Complex with the QLD heritage register boundary in red.

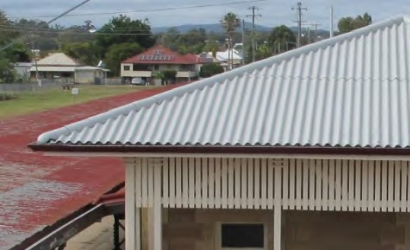
Neutral	1960s fabric, replaced after fire – corrugated asbestos cement
Station	Front portico

The main roof to the station is not original – the timber frame, roof sheeting, gutters and downpipes were replaced in the 1960s. It would be a major exercise to reconstruct the original station roof form but would be feasible as the original 1886 drawings and specification are available. Roof sheeting to the main station building is asbestos and will require replacement when it becomes friable. As this roof sheeting is not original, replacement with a corrugated steel profile would be acceptable. Other roofs to the kitchen wing, platform awnings, gent’s toilet and ambulance room are original and should be conserved.

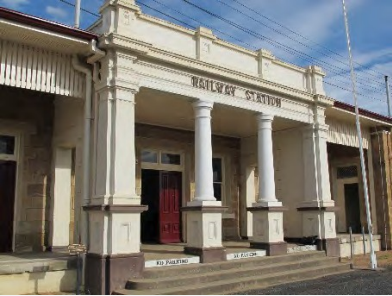
High	Original entrance portico
Station	Front verandahs each side of portico

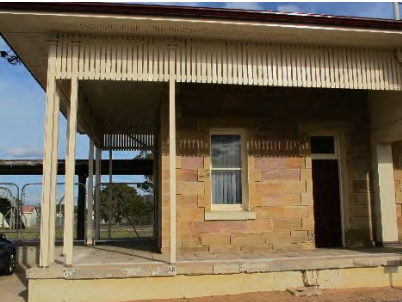
Neutral	Concrete floors, timber posts and timber frieze rebuilt after 1964 fire
External walls, windows, doors				
Station	Sandstone walls

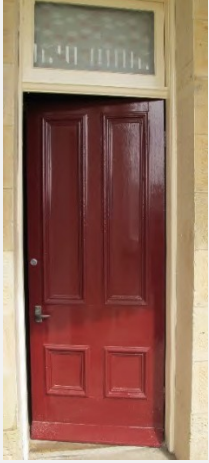
Rooms 1, 3A, 8,	Single, timber door with fanlight above

Neutral	Reproduction double doors installed after 1964 fire – centre panels are not raised
Rooms 4, 5, 8	Flush panel door

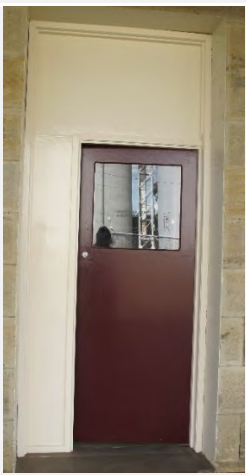
Intrusive	Recent replacement doors, some are solid, some with glass panel at top
Interior				
Rooms 11, 12	Beaded timber tongue and groove ceiling

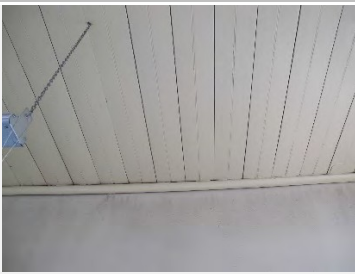
Exceptional	1886 fabric to original kitchen wing
Room 13	Narrower VJ ceiling

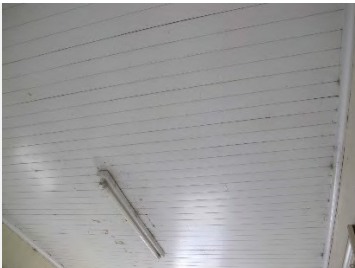
High	1912 fabric to kitchen wing

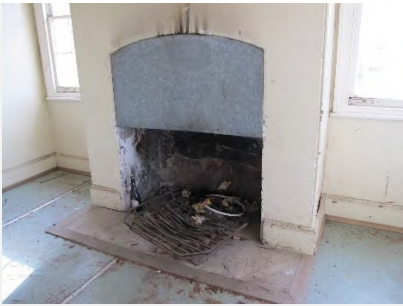
Door – Neutral Architraves and fanlight - High	Recent door within original opening
Rooms 6, 8, 11	Fireplaces, Chimney Breasts

High	Room 6 – 1912 Room 8 – 1886 Room 11 – 1886 Mantlepieces and surrounds are missing
Rooms 11, 12	Timber flooring and steps

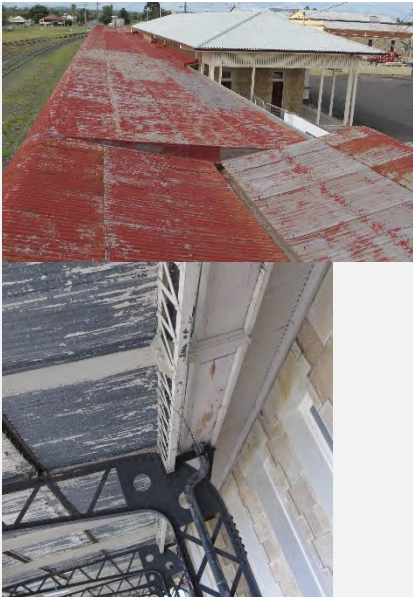
Location	Name	Photo	Significance	Reason for significance
Platform Awning roofs	Roof sheeting, box gutters, downpipes

High	Original 1925 and 1934 fabric – galvanized, corrugated steel
Platform awning supports	Steel columns and girders

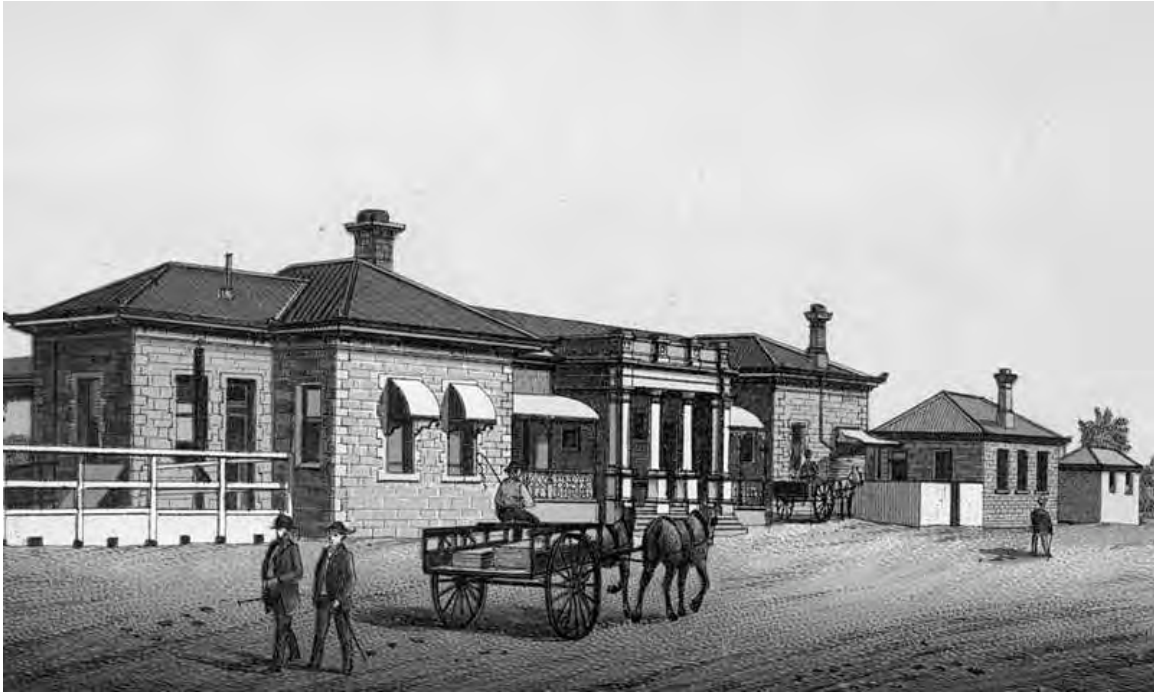
Figure 10 Drawing of entrance to Warwick Passenger Station 1889. Source:

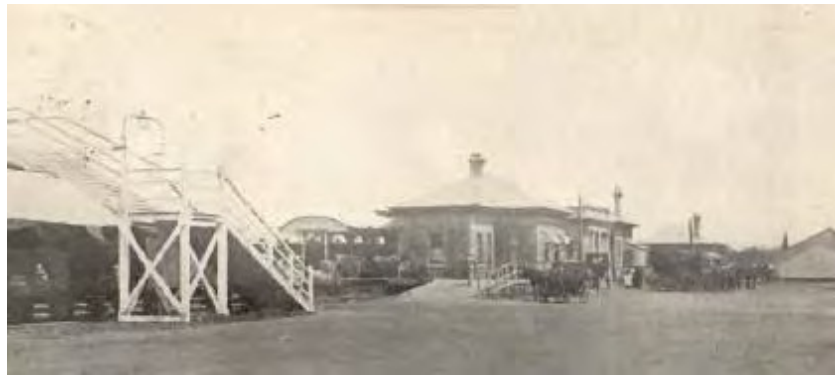
*Figure 18 Warwick Station 1908, showing the original timber footbridge which was built in 1900 and demolished in 1913.
Source: QR Collection*

Prior to 1900, people living near the station had developed the risky habit of walking through the railyards as a shortcut. To solve this problem, a timber footbridge was constructed across the lines in 1900. The contractor was Tighe Bros who signed a contract on 28 November 1899.⁸⁵ Specifications for the first timber footbridge are available at Queensland State Archives – Item ID 649466.⁸⁶

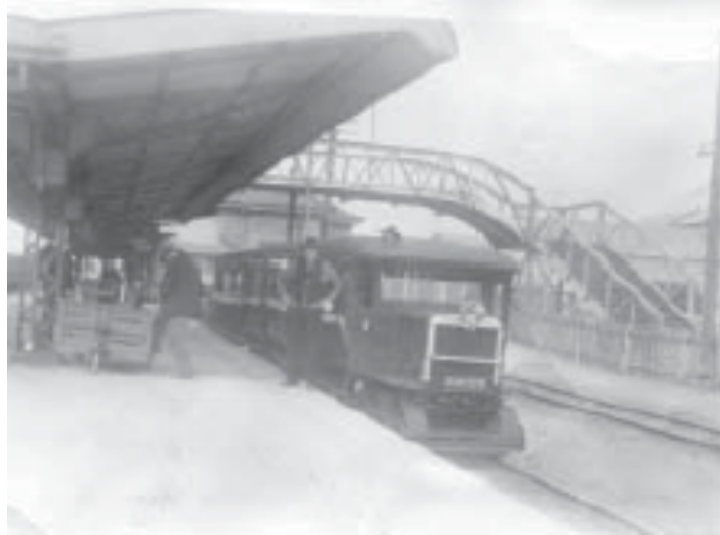
Figure 21 Rail motor RM30 at Warwick Station, with the replacement 1913 footbridge in the background. Source: QR Collection

The footbridge crosses the yard in 3 c.60' spans with approach spans, the supports being marked D.L. and Co. Ltd (possibly Dorman Long and Co.) back to back T sections with angle iron braces and curved stays to the bridge trusses. The steps and deck are of timber and although not as decorative as the now demolished footbridges at Toowong and Roma St, the western span incorporates the graceful upwards curve characteristic of these earlier bridges.⁸⁹

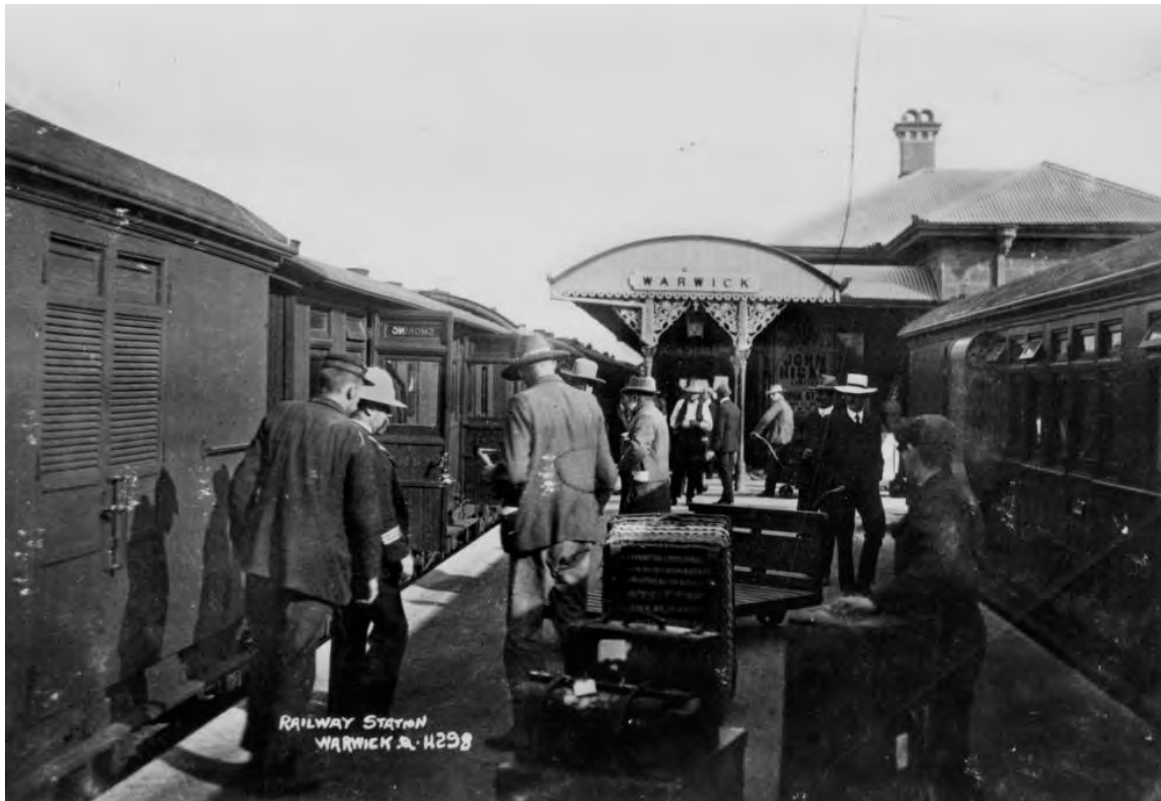
Figure 32 Warwick Passenger Station c1911 showing northern end of original umbrella shade. Source: Picture Queensland

By 1934 plans were made to replace the original 1886 umbrella shade (and 1926 extension) with a new steel framed cantilevered platform shade. The design of the original 1886 umbrella-style platform shade with its iron columns along the platform were seen to be an obstruction to the easy movement of passengers and luggage.

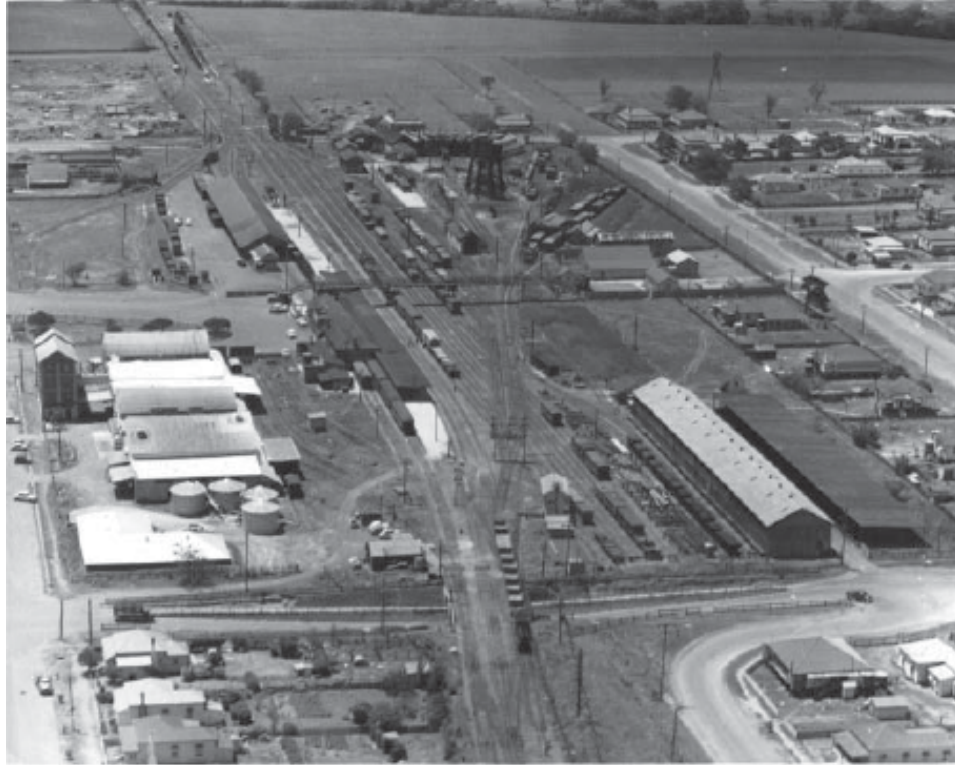
Figure 34 Warwick Railway Station Complex, 1950s, aerial view showing the two butterfly shades from 1925 at either end of the platform, and the cantilevered platform shade erected in 1936 in place. Source: Southern Downs Steam Railway - Taken from (Buchanan Architects, 2003)

The new steel cantilevered platform shade was estimated to cost £870 and the tender for construction of the steel frame was awarded to A. Sargent & Co of Alice Street in Brisbane. Plans from the Department of Railways were supplied to the contractor and were of a standard design used widely in Queensland at the time. At the same time as the cantilevered shade was constructed for Warwick, similar shades were constructed at Graceville, Bundaberg, and Nundah stations. Erection of the cantilevered shade was completed by 1936. The butterfly shades and the cantilevered shades remain in place in 2018.

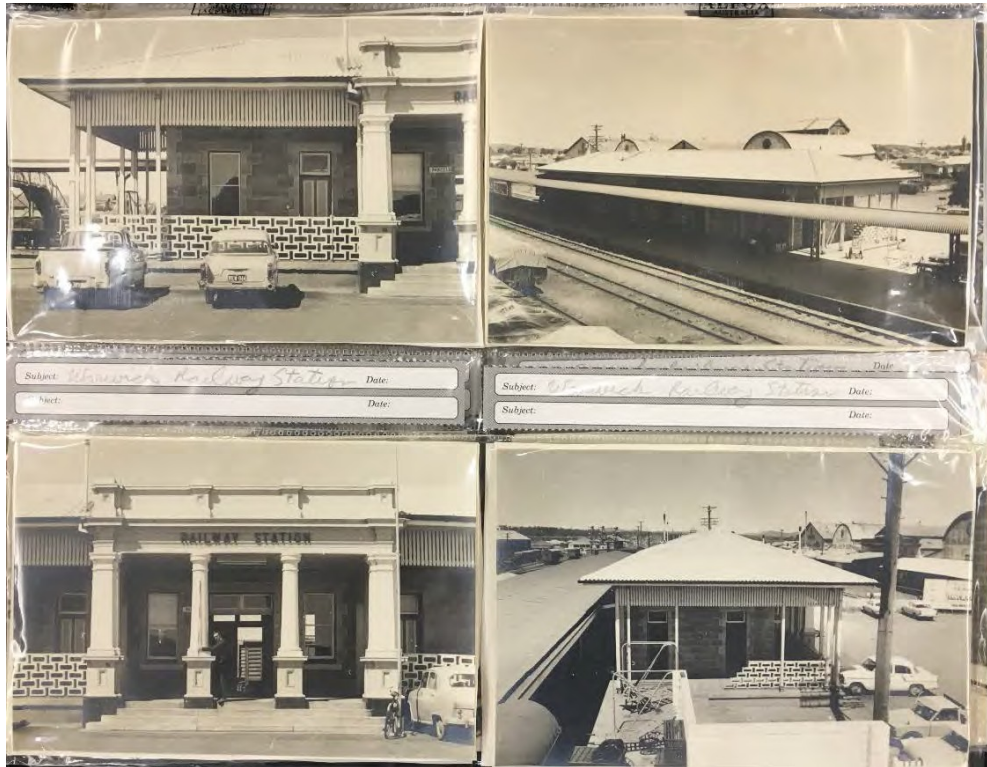
Figure 35 The passenger station in 1968 showing changes after the fire of 1963. Source: QSA Department of Public Works Album for Warwick.

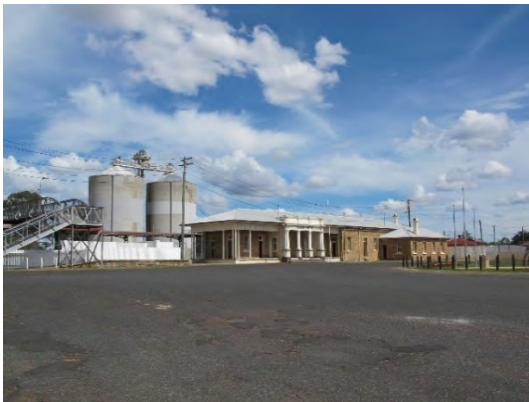
Figure 37 Forecourt of Warwick passenger station with footbridge at left and memorial park at right

The passenger station is a single-storey sandstone and brick building with the rail line on its eastern side. The western side features a central entrance portico, which is rendered with columns and pilasters of Tuscan order mounted on pedestals. Above, is a parapet with the words 'Railway Station' in steel lettering. Small verandahs flank the entry on each side. The main, hipped roof is corrugated asbestos cement sheeting and the roof to the kitchen wing is of corrugated steel sheeting. There are two rendered chimneys with decorative mouldings. The station has had two major alterations since its construction – the first in 1912 with the addition of a large extension for refreshment rooms; the second after the fire in 1964, which resulted in demolition and alterations to part of the northern section and the roof of the station.

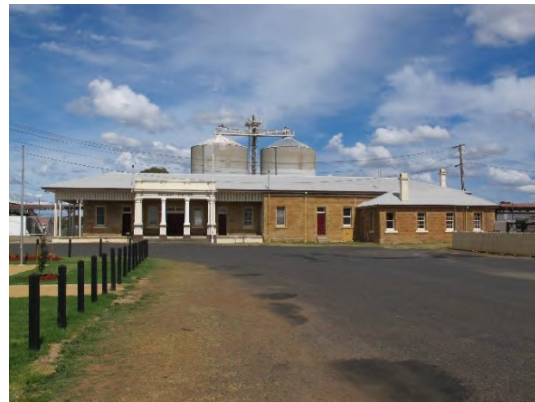
Figure 38 Eastern elevation of Warwick passenger station, kitchen wing at right.

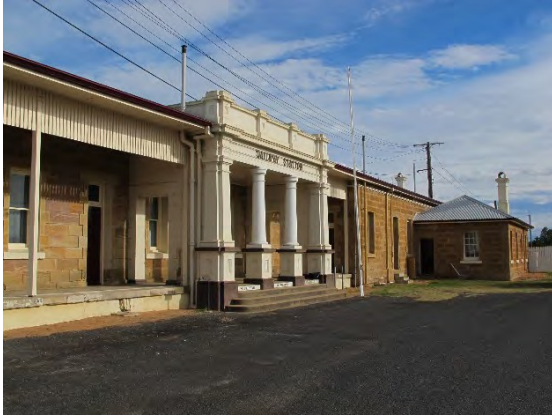
Figure 39 Eastern façade of passenger station.

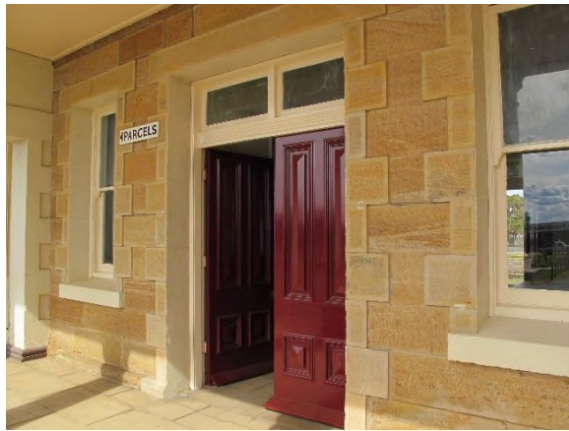
The walls of the station building are sandstone, laid in edge-margined ashlar coursing with picked finish. The stones of the quoins, openings and corners project slightly. Stonework to the southern half of the building (c.1912) is more finely finished with white tuckpointing. Stonework to the northern, earlier part of the building is of rougher texture and not tuck pointed. External windows are of timber double-hung sashes, with single-light sashes to the main building and six-light sashes to the kitchen wing. Some of these windows are original fabric, those to the northern end are reproductions installed after the fire damage. Original doors are of bolection moulded paneled design with glass fanlights over, reproduction doors are in a similar style. Sills to windows are of sandstone.

Figure 42. Sandstone walls with quoins to door and window openings.

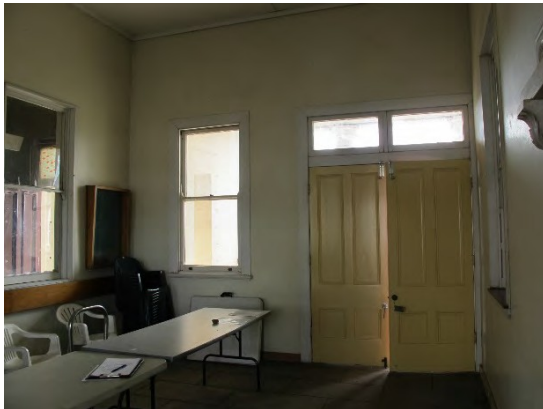
Figure 45. Ticket Hall with ticket windows at each side.

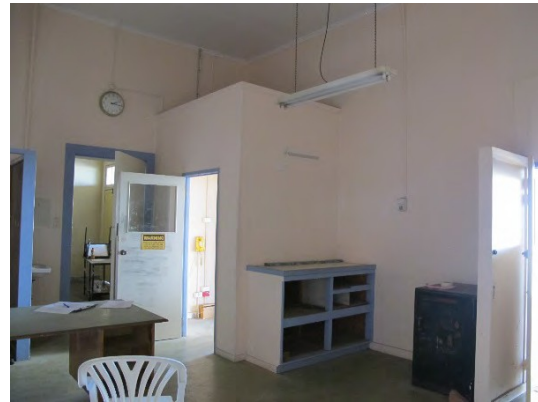
Figure 46. Inserted partition wall in Parcels Office.

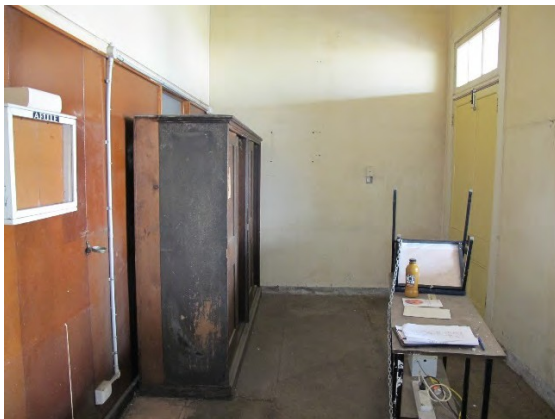
Figure 47. Former Telegraph Office divided into smaller spaces.

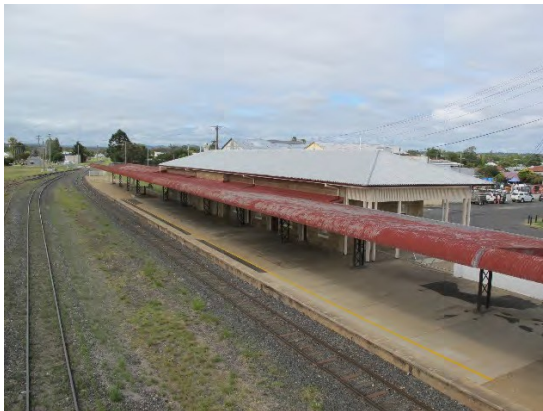
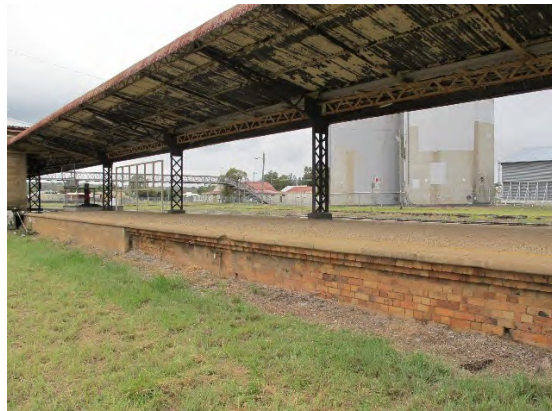
The platform awnings are made up of cantilevered, steel lattice columns and girders, which extends to double cantilever (butterfly) roof-forms to the north and south of the passenger station building. The roof sheeting of the platform shade is corrugated galvanized steel with bullnose profile towards the rail line. The platform is concrete over a brick base, with precast concrete coping. The earlier sections of platform contain stone walls. A set of signals is located at the southern end of the passenger station platform.

Figure 51. View of rail side of station with platform awnings. Figure 52. Brick and concrete platform and awning.

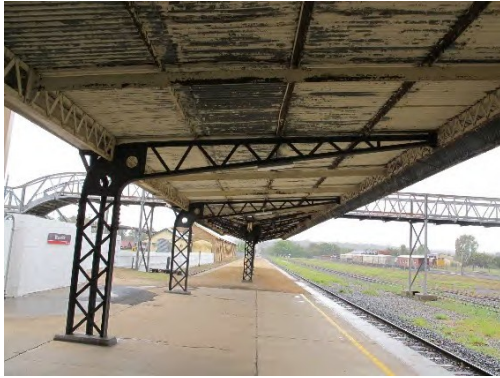
Figure 53. Cantilever type platform awning.

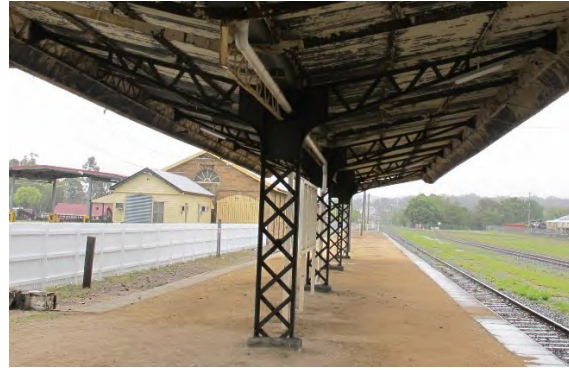
Figure 54. Butterfly type platform awning.

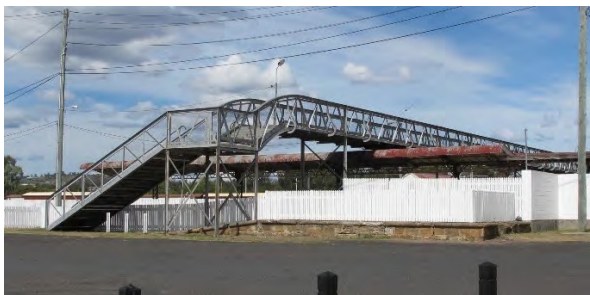
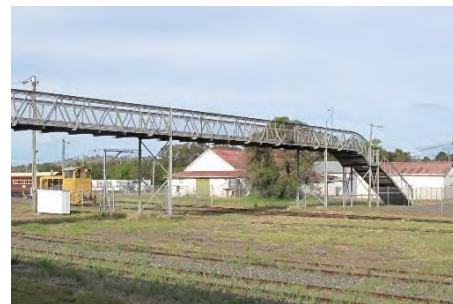
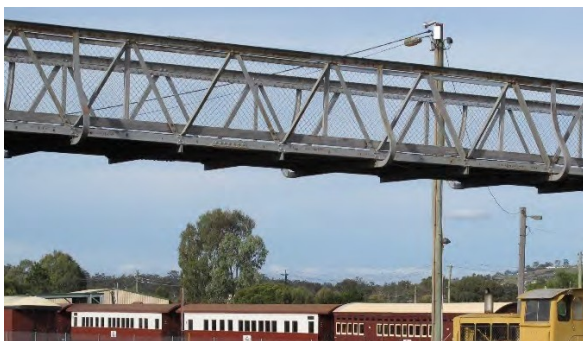
The footbridge was constructed in 1912, replacing an earlier timber footbridge. It is constructed of steel angles with rivetted and bolted connections, supported by steel angled and braced supports set into concrete footings. The stairs at each end have timber step treads with chain-wire mesh balustrades. The bridge section has timber plank flooring and curved steel balustrades with chain-wire mesh infills. Some of the steel members bear the manufacturer's name, 'Dorman and Long'. The bridge is approximately 17 metres long with approach spans of 7.5 metres.

Figure 55. Western end of footbridge, near Station.

Figure 56. Eastern end of footbridge.

Figure 57. Footbridge over railway tracks

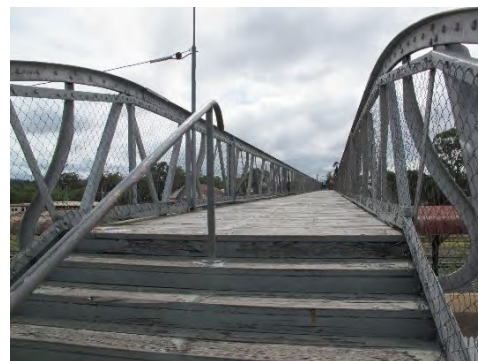
Figure 58. Timber steps and deck of footbridge.

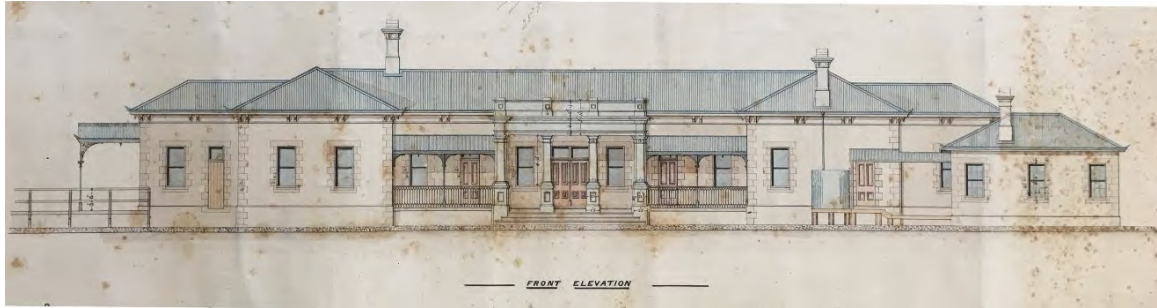
Figure 64. Warwick passenger station original front elevation - extract from drawing dated 25.5.1886. Source: QSA Series 17692 Plans of Queensland Railway Station Buildings etc., Item ID 120966.

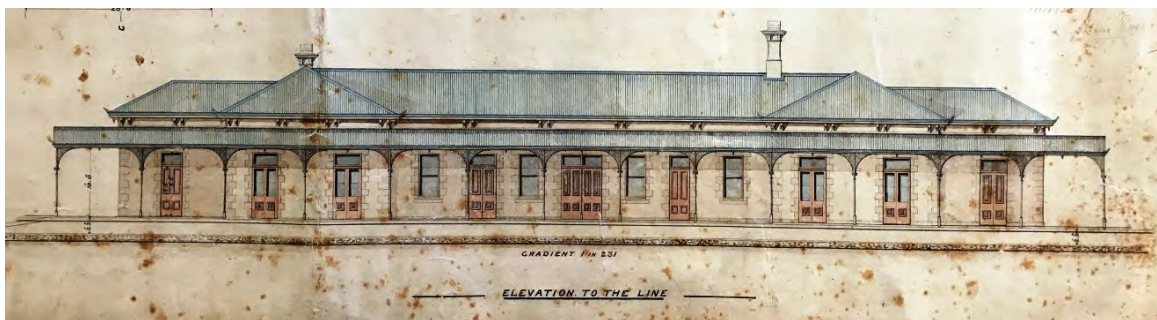
Figure 65. Warwick passenger station original elevation to railway line - extract from drawing dated 25.5.1886. Source: QSA Series 17692 Plans of Queensland Railway Station Buildings etc., Item ID 120966.

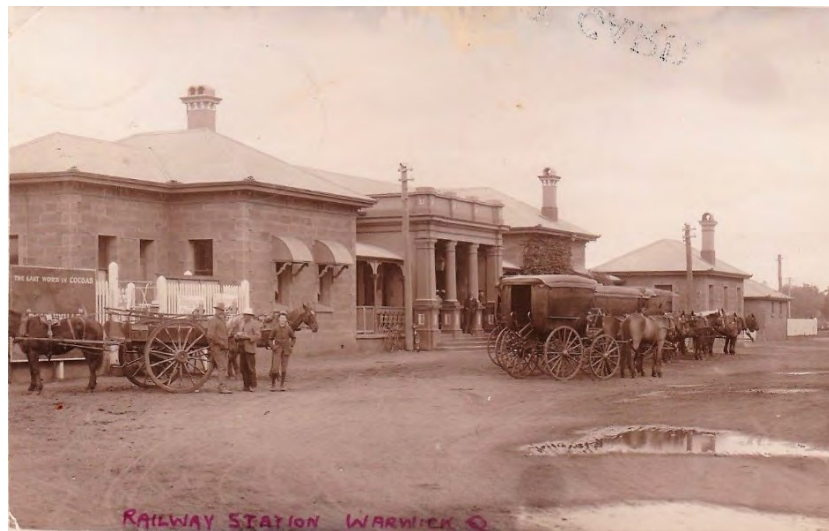
Figure 68. Photograph of Warwick railway station before the 1912 addition - note the curved verandahs each side of the portico, window hoods and single-light windows. Source: Trove

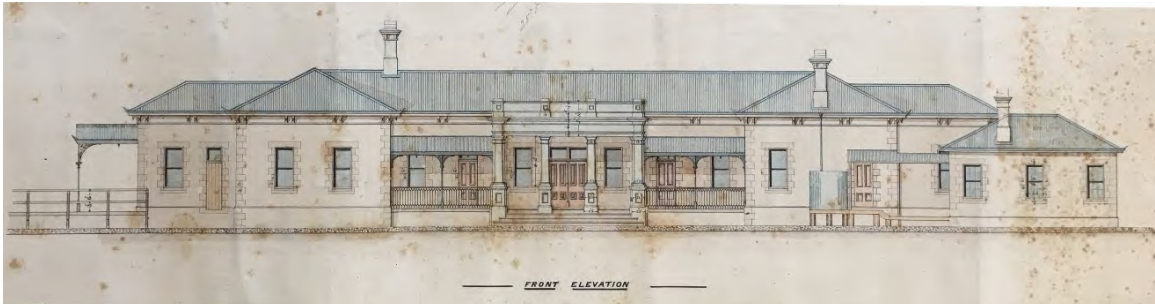
Figure 78. Comparison of original 1886 station and the station today. Note, the kitchen wing was joined to the main building in 1912, the northern end of the building was demolished after the 1964 fire and the roof rebuilt in a simpler form.

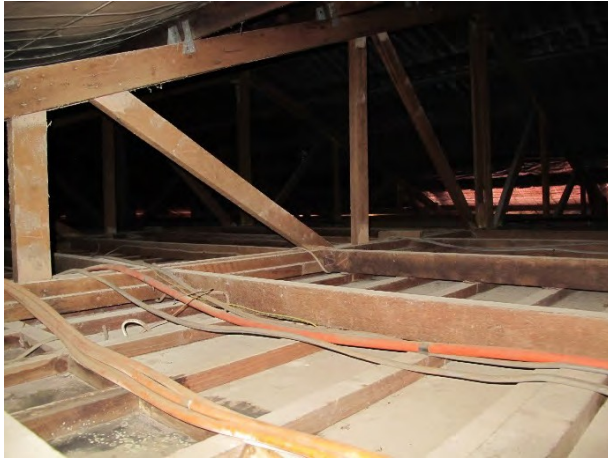
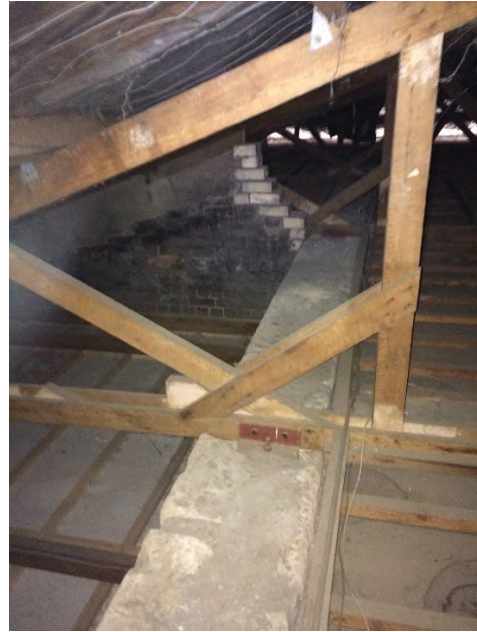
Figure 79. 1960s timber roof and ceiling framing to main building. Figure 80. Inside roof – tops of stone and brick walls.

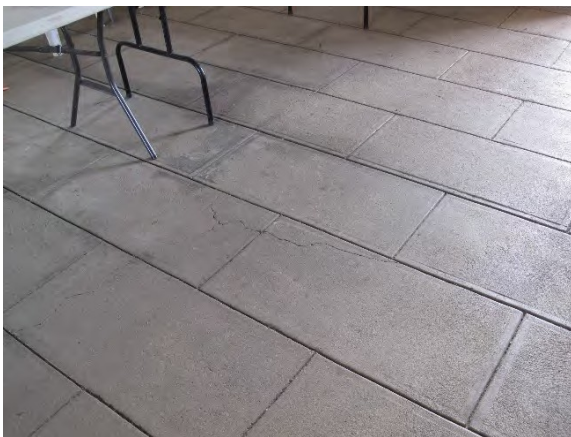
The floors to rooms 1 and 2 were reconstructed with concrete flooring slabs after the 1964 fire. Timber floor framing and floor boards survive in the kitchen wing and in the 1912 refreshment room.

Figure 81. 1960s concrete floor slabs in room 2.

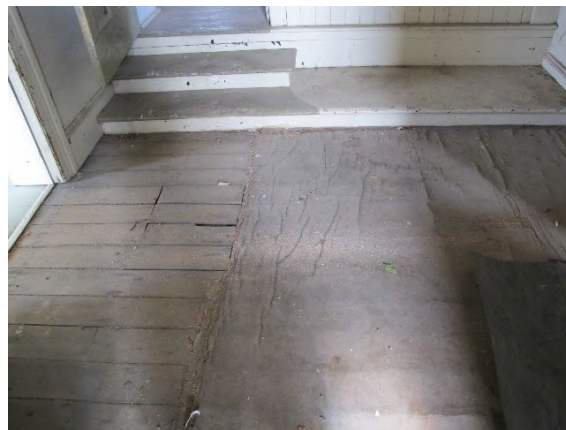
Figure 82. 1886 timber flooring in room 12.

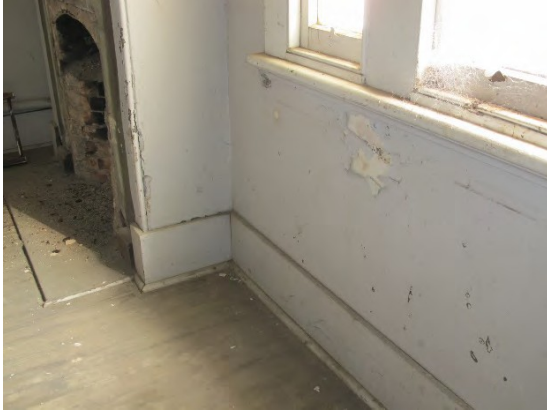
Figure 83. Original plaster wall in room 6.
12.

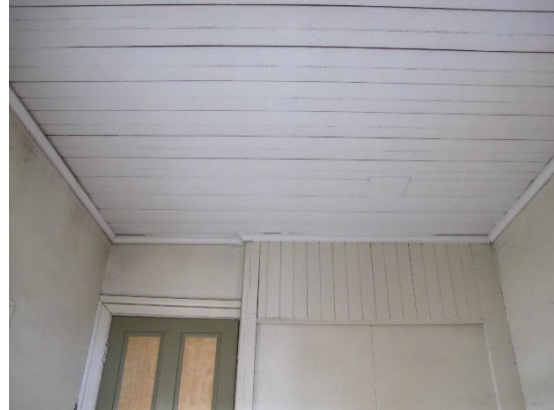
Figure 84. Original timber ceiling and plaster walls in room 12.

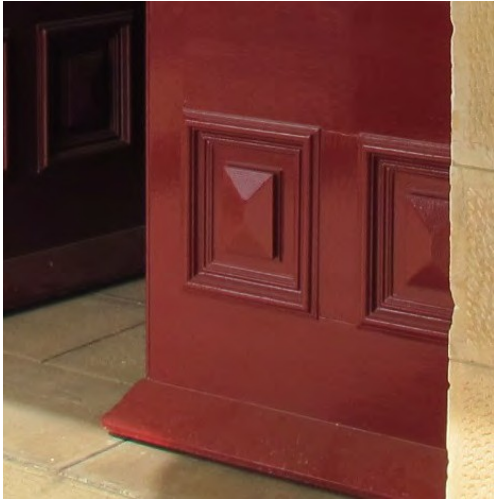
The timber doors in rooms 1 and 2 were replaced after the fire and are reproductions. These reproduction doors do not have raised panels inside the bolection mouldings, whereas the original doors in the southern part of the station feature raised panels of a flat, pyramidal shape – refer figures. The exception are the reproduction doors to Room 2 (the large, double entrance doors), which have raised panels that are smaller and in a different configuration to the original raised panels. The door hardware was largely replaced in the 1960s renovations, with uniform lever handle fittings.

Figure 86. Reproduction doors with smaller raised panels.

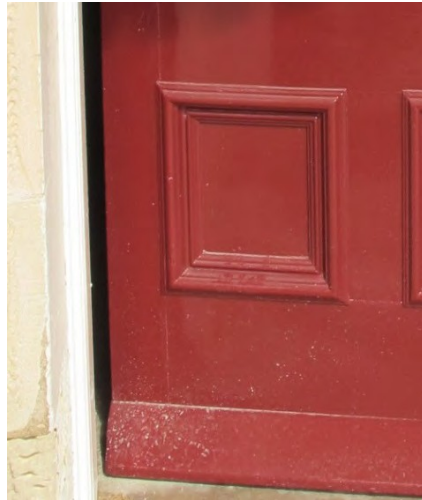
Figure 87. Reproduction door with flat panels.

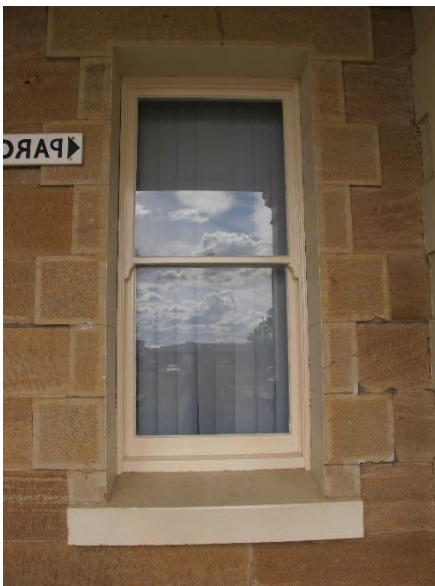
Figure 88. Single-light reproduction window in room 1.

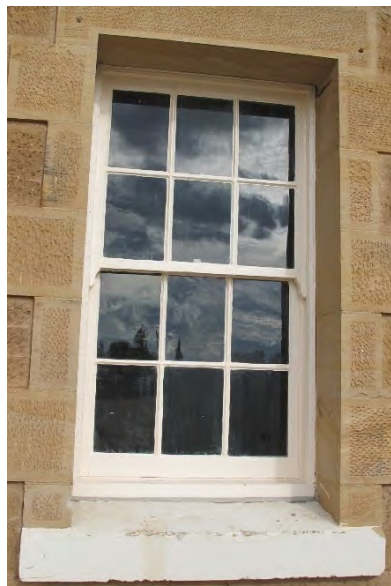
Figure 89. Six-light original window in kitchen wing.

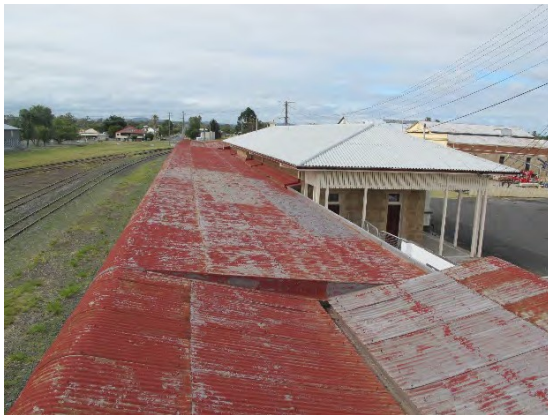
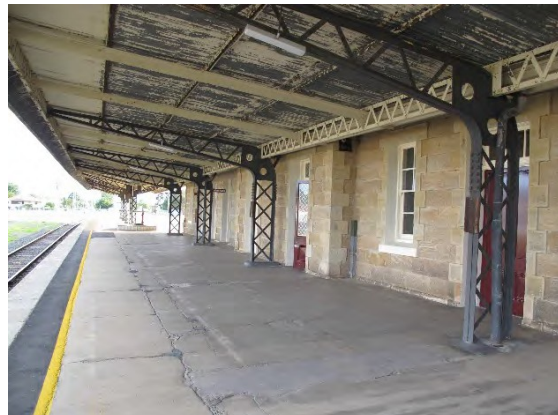
Figure 97. Top of awnings showing join between cantilever and butterfly roofs. Figure 98. Cantilevered platform awning.

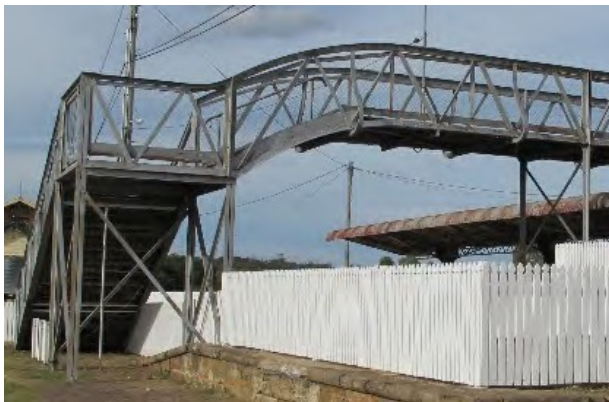
The steel footbridge, built in 1912 to replace the original timber footbridge, is largely intact including the steel frame and supports. Some of the timber step treads and planks have been replaced as the timber has deteriorated. The timber-framed chain-wire balustrades are not original fabric and were probably installed for safety reasons.

Figure 100. Steel footbridge at Lyons Street end.

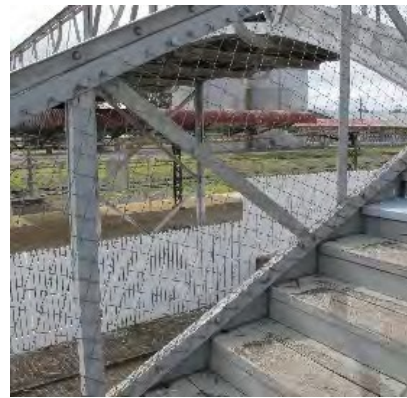
Figure 101. Non-original timber and chain wire inserts.

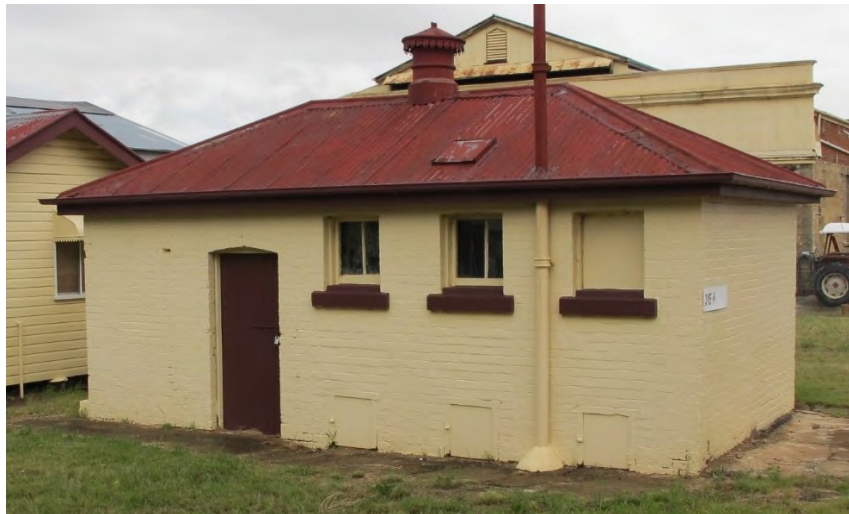
Figure 105. Former gent's toilet with hatches for emptying toilet pans intact.

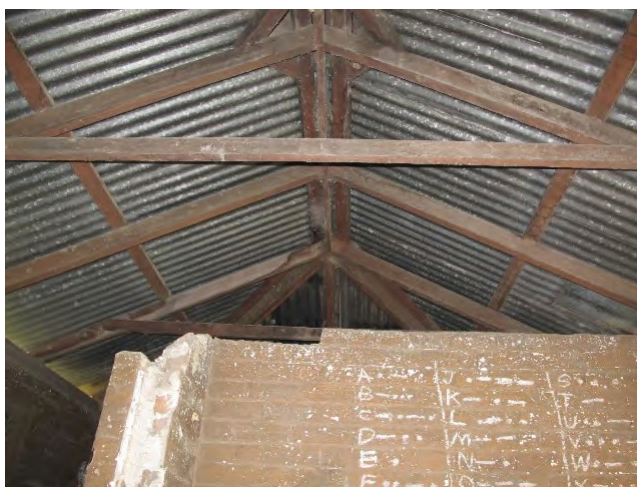
Figure 106. Original roof framing and brick wall to gent's toilet.

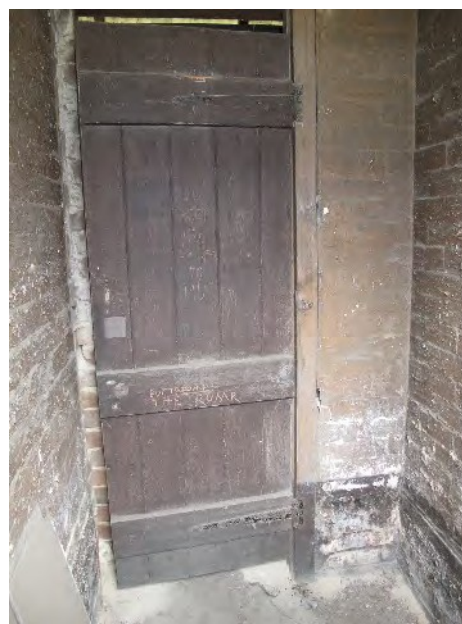
Figure 107. Original toilet cubicle with timber door.

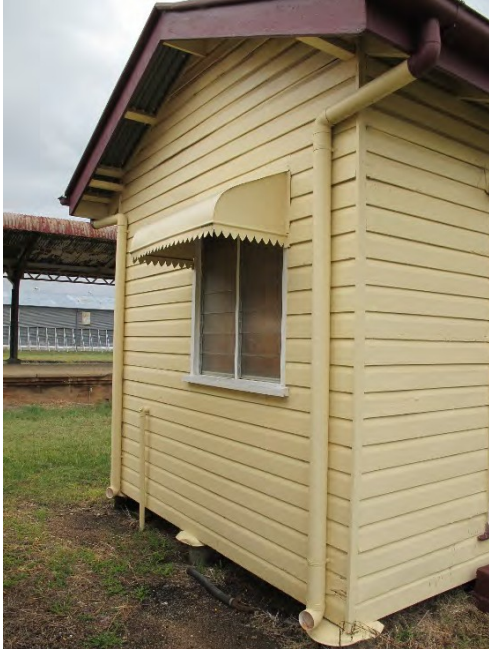
Original drawings of the former ambulance room have not been found and its age is uncertain. It may have been relocated to this site. The timber framed building consists of a single room with a gable roof and is low-set on stumps. The windows have been replaced with glass louvres and the interior walls and ceiling have been lined. The chamferboard walls, roof sheeting and floor framing appear to be original fabric.

Figure 108. Exterior of ambulance room.

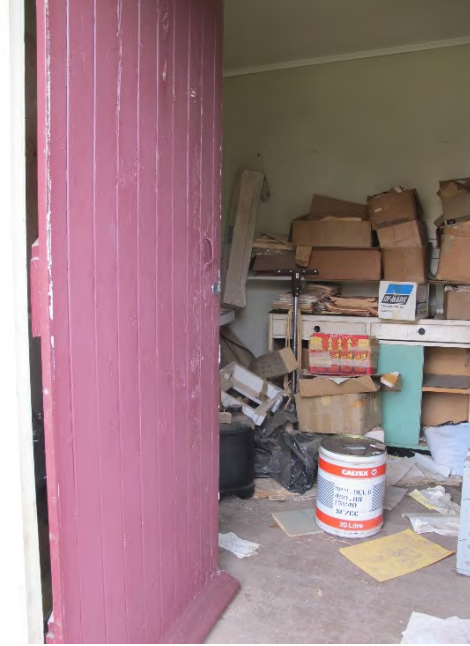
Figure 109. Interior view of ambulance room.
